Bilder

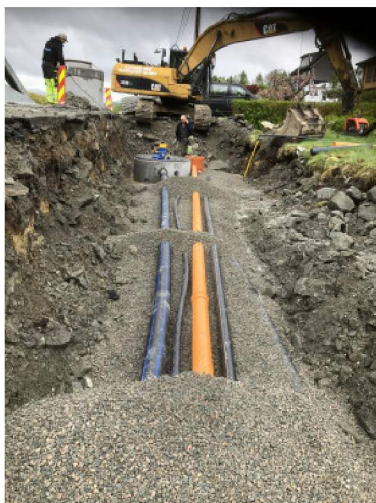
Filnavn: IMG_3804.jpg

Kommentar:
Til VK1 og SK1

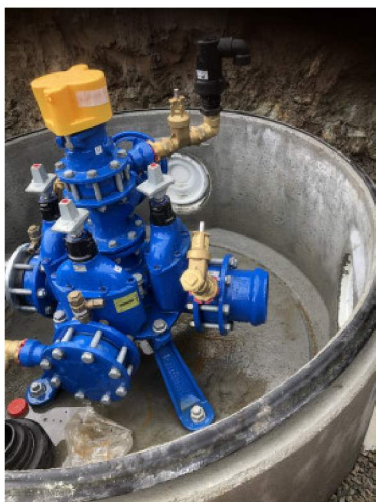
Filnavn: IMG_3803.jpg

Kommentar:
SK1

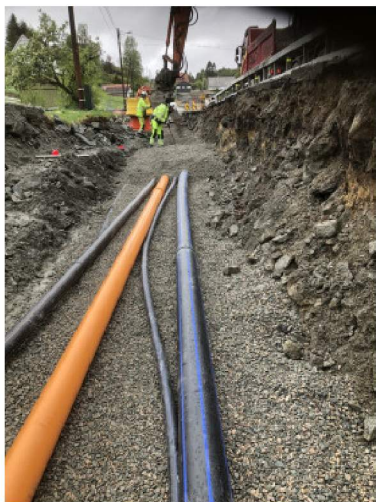
Filnavn: IMG_3801.jpg

Kommentar:
Mellom SK1 og SK2

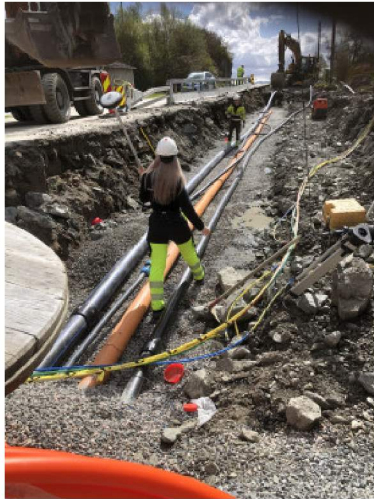
Filnavn: IMG_3744.jpg

Kommentar:
Fra SK1 mot SK2

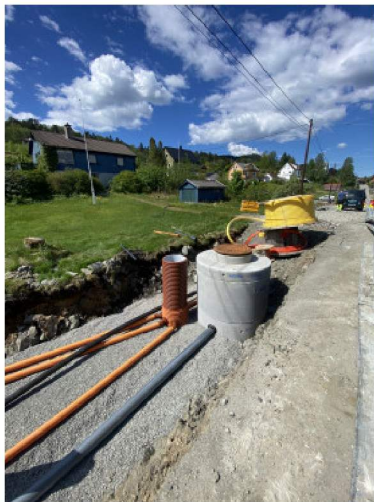
Filnavn: 58257F90-2EE8-4A42-9311-9CDBC3943E84.jpeg

Kommentar:
VK1 og SK1

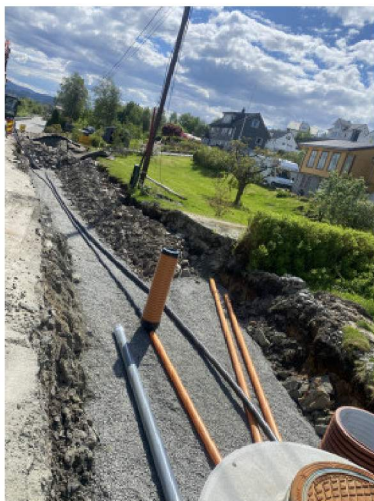
Filnavn: 11DE5857-6133-4F99-9DD0-44108279F769.jpeg

Kommentar:
Fra SK1 mot eksisterende

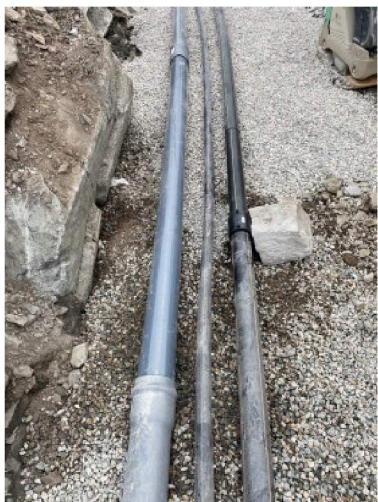
Filnavn: 25788B62-FEAD-4E65-899D-A91B4E19FFC7.jpeg

Kommentar:
Sammenkobling fra VK1 mot eksisterende med PVC rør

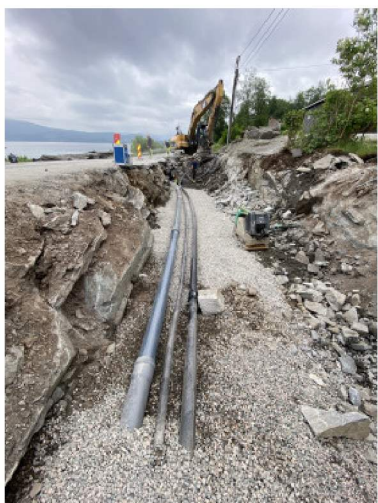
Filnavn: 2019BCCE-FEBF-47A7-961A-9CD45C62313C.jpeg

Kommentar:
Sammenkobling fra VK1 mot eksisterende med PVC rør

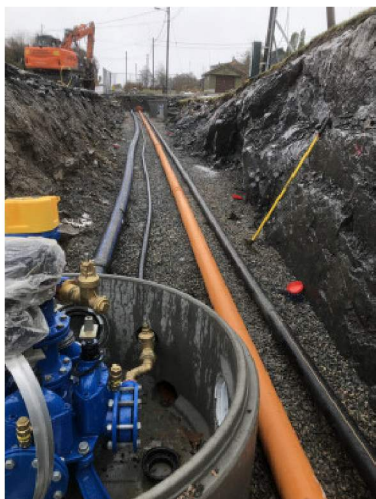
Filnavn: 87CC77DF-AB5B-4E76-A5F1-D1D74E40A26F.jpeg

Kommentar:
Fra VK2 mot SF1

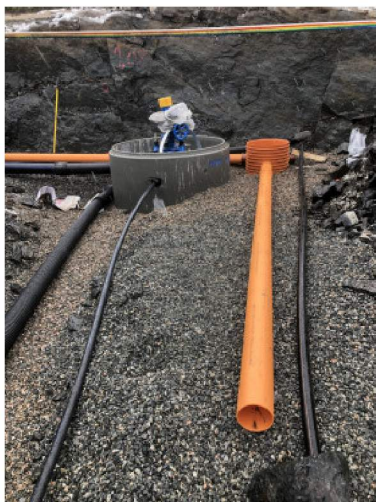
Filnavn: 13CE672C-A314-4E61-8A73-E8E4E2E67B0D.jpeg

Kommentar:
VK2 og SK3

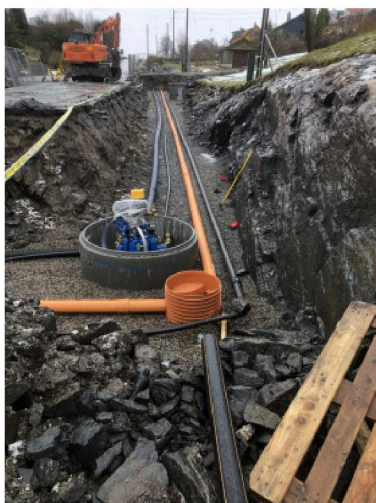
Filnavn: FD5BB913-8C59-4640-9BE5-345F8DB8D89C.jpeg

Kommentar:
VK2 og SK3
