Monitoring of runoff from quarry at Kaland, Mongstad

Risk assessment of deposited solids from TCC
RotoMill process

Date: 28. February 2012	Availability: Closed	Project No.: 8153	Archive No.:
Report No.: 149/2011	ISBN-no:	Number of pages: 18	Number of appendices: 0
Employer: TWMA		Contact person: John-Kåre Krokene	
Keywords: Processed drill cuttings, TCC RotoMill-process, local risk assessment		Field of work: Waste and Environmental Contaminants	
Summary: During autumn 2011 runoff samples from quarry Kaland were sampled to give an indication on the influence of deposited solids from the TCC RotoMill process on runoff quality. Samples were collected at 12. and 30. September, and 5. November 2011 from 3 (4) locations in a passing stream. pH, Conductivity, Dissolved organic carbon (DOC), Arsenic, Copper, Chromium, Nickel, Barium, Cadmium, Lead, Zinc, Molybdenum, Antimony, Chloride, Sulphate and Hydrocarbons (C10-C35) were determined in the water samples. In this report the quality of the stream samples is summarized and an initial risk assessment is given.

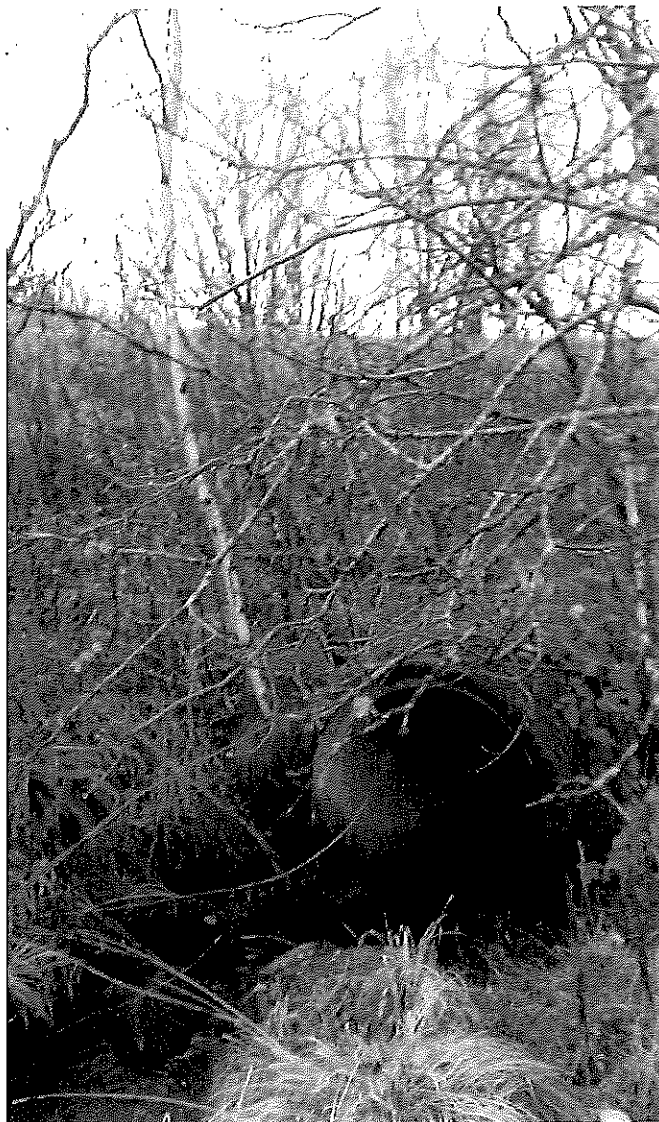
Figure 4-1: Stream from south passing the road in culvert (Reference). Road can be seen above.

A sampling point was established in the stream after passing through a culvert by the road (57) (Figure 4-1). Prior to running into the quarry area it is probably influenced by other sources (roads, dense surfaces, industry etc). Water quality in the stream at this site will be important for evaluating the influence of the restoration site on water quality flowing out from the area.

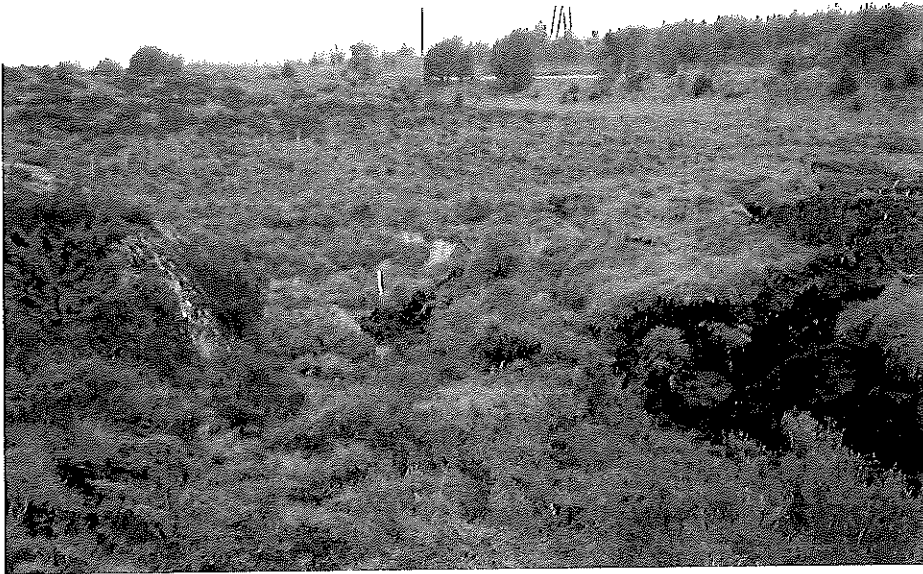
Figure 4-2: Well (white stick) and trickle west of the front of the restoration site (front of restoration area to the right).

Surface runoff (trickle) northwest of the restoration site (Figure 4-2) was sampled at 12. September. Measurements of conductivity in the surface runoff showed that the runoff at points was quite concentrated with salts. Runoff from a marsh west of the site rapidly dilutes the salty runoff before it runs into the main stream north of the quarry.

12. September a groundwater well was installed. A PE-pipe (54mm inner diameter) was knocked through the bog and about 1m into the clay underground. After installation the pipe was emptied several times to remove clay particles. The well was sampled 30. September and 5. November.

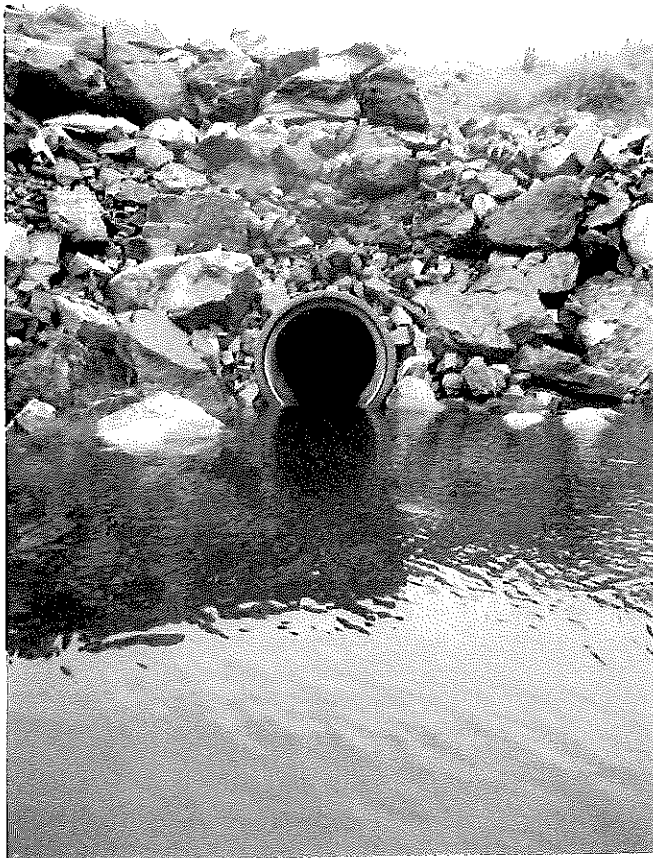
Figure 4-3: Stream going through culvert by the quarry. Sampling at this site was done only 12. September.

The stream running parallel to the quarry (east) runs through a culvert in the northern part (Figure 4-3). At this point the stream is influenced by runoff from a large part of the restoration site, but to a smaller extent of deposited solids from the TCC RotoMill process. Sampling at this point was only performed 12. September.
