Vol. 6 Nr. 149/2011

Monitoring of runoff from quarry at Kaland, Mongstad

Risk assessment of deposited solids from TCC
RotoMill process

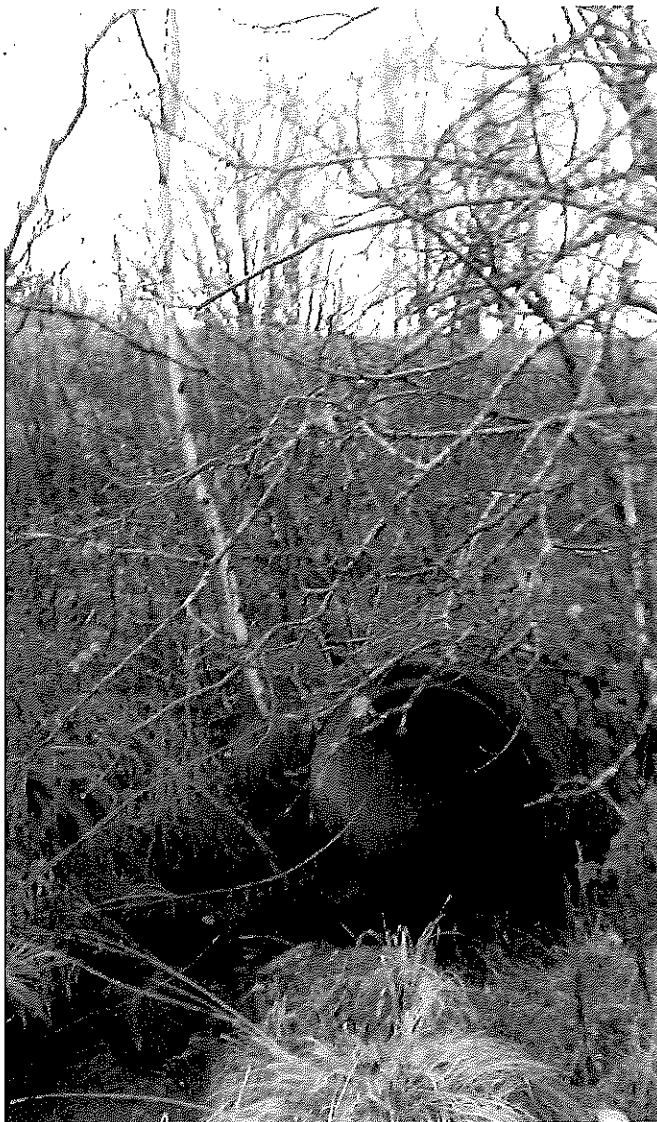
Figure 4-1: Stream from south passing the road in culvert (Reference). Road can be seen above.

A sampling point was established in the stream after passing through a culvert by the road (57) (Figure 4-1). Prior to running into the quarry area it is probably influenced by other sources (roads, dense surfaces, industry etc). Water quality in the stream at this site will be important for evaluating the influence of the restoration site on water quality flowing out from the area.

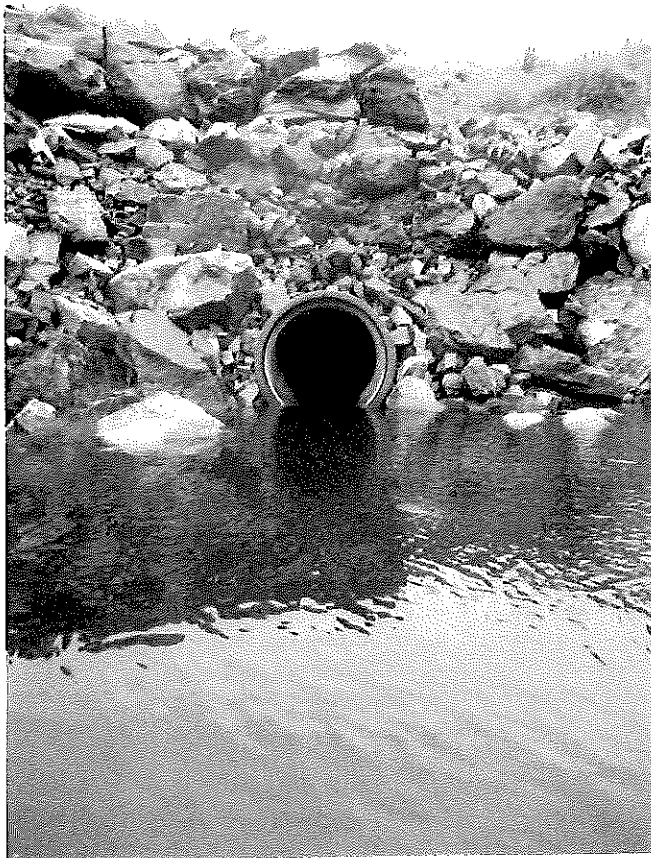
Figure 4-3: Stream going through culvert by the quarry. Sampling at this site was done only 12. September.

The stream running parallel to the quarry (east) runs through a culvert in the northern part (Figure 4-3). At this point the stream is influenced by runoff from a large part of the restoration site, but to a smaller extent of deposited solids from the TCC RotoMill process. Sampling at this point was only performed 12. September.
