Vol. 6 Nr. 149/2011

# Monitoring of runoff from quarry at Kaland, Mongstad

Risk assessment of deposited solids from TCC  
RotoMill process

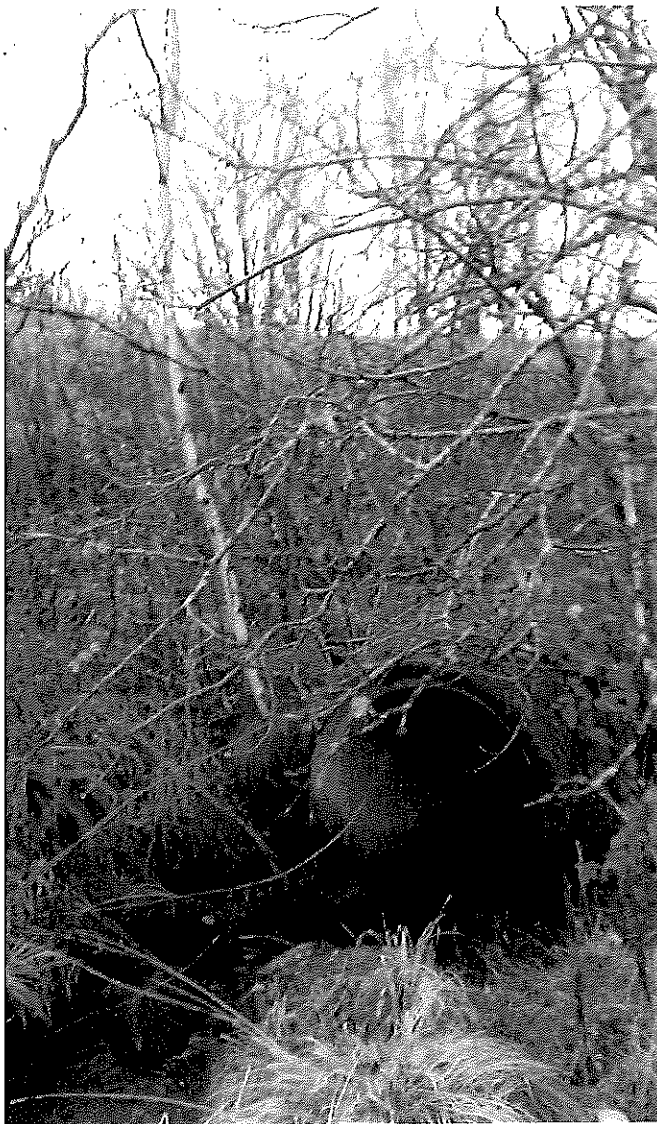
A sampling point was established in the stream after passing through a culvert by the road (57) (Figure 4-1). Prior to running into the quarry area it is probably influenced by other sources (roads, dense surfaces, industry etc). Water quality in the stream at this site will be important for evaluating the influence of the restoration site on water quality flowing out from the area.

*Figure 4-1: Stream from south passing the road in culvert (Reference). Road can be seen above.*

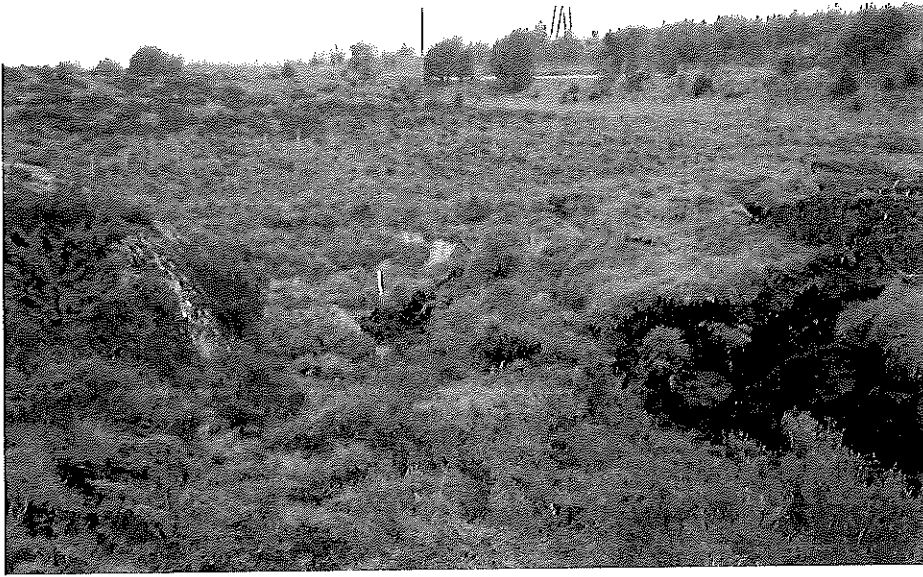
Surface runoff (trickle) northwest of the restoration site (Figure 4-2) was sampled at 12. September. Measurements of conductivity in the surface runoff showed that the runoff at points was quite concentrated with salts. Runoff from a marsh west of the site rapidly dilutes the salty runoff before it runs into the main stream north of the quarry.

12. September a groundwater well was installed. A PE-pipe (54mm inner diameter) was knocked through the bog and about 1m into the clay underground. After installation the pipe was emptied several times to remove clay particles. The well was sampled 30. September and 5. November.

*Figure 4-2: Well (white stick) and trickle west of the front of the restoration site (front of restoration area to the right).*

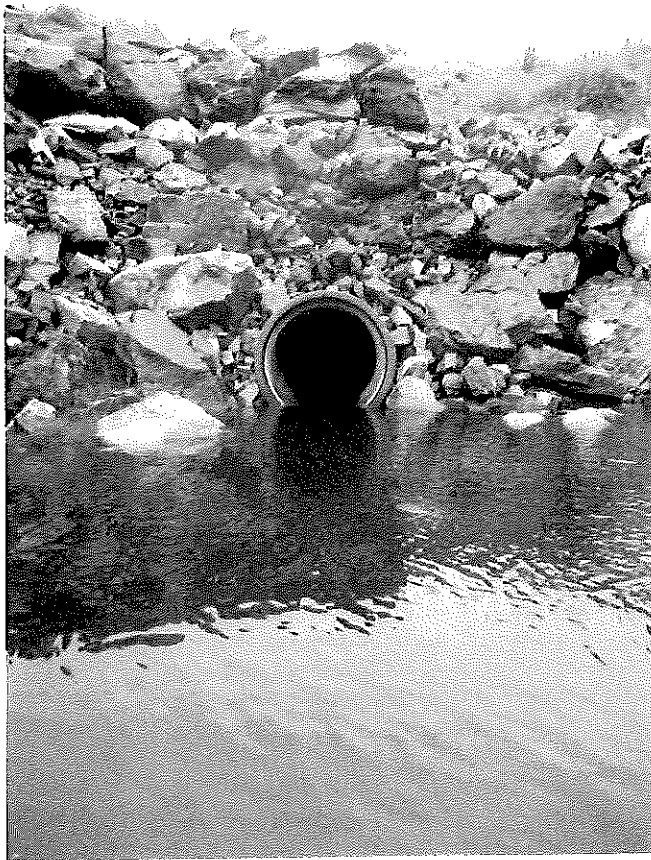
The stream running parallel to the quarry (east) runs through a culvert in the northern part (Figure 4-3). At this point the stream is influenced by runoff from a large part of the restoration site, but to a smaller extent of deposited solids from the TCC RotoMill process. Sampling at this point was only performed 12. September.

*Figure 4-3: Stream going through culvert by the quarry. Sampling at this site was done only 12. September.*

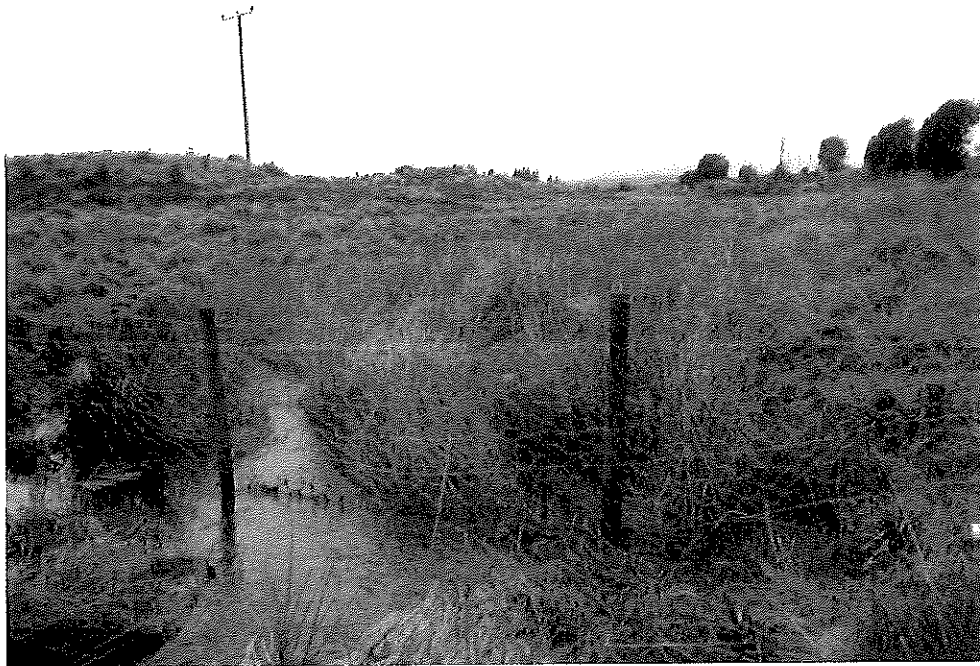
The stream runs north after the last culvert (3). About 50meters north of the restoration site a sampling point was established (Figure 4-4). At this point surface runoff and groundwater are mixed with the stream running north from the quarry.

*Figure 4-4: Stream from the restoration site going north towards the sea. Sampling of runoff was done at the fence.*
